Manhole Inspection Summary

Manhole # S33EE_F03MH

Record Plat: **33EE** Node: **F03** Status: **New Manhole (Not in GIS)** Insp Date: **2/28/07 12:00 AM**

Location Address: **MARTIN LUTHER KING JR BLVD** Cross Street: **HOWARD ST**

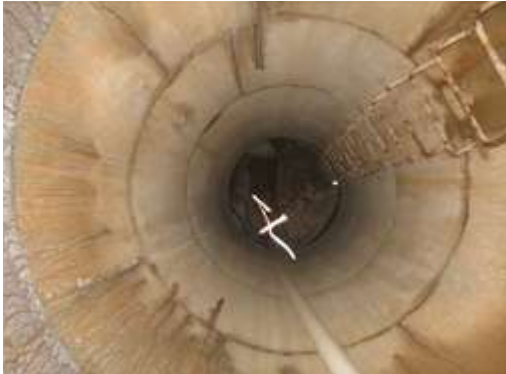
Defect

Barrel infiltration. Bench and Channel debris.

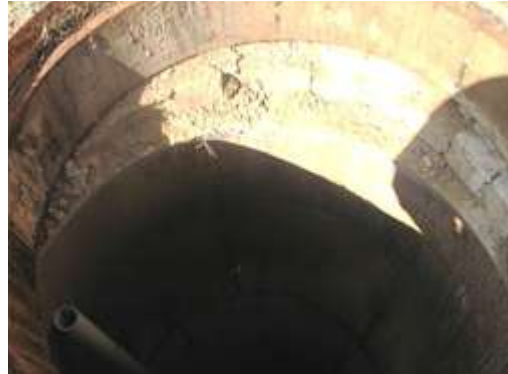
Defect

Corbel and Barrel infiltration.

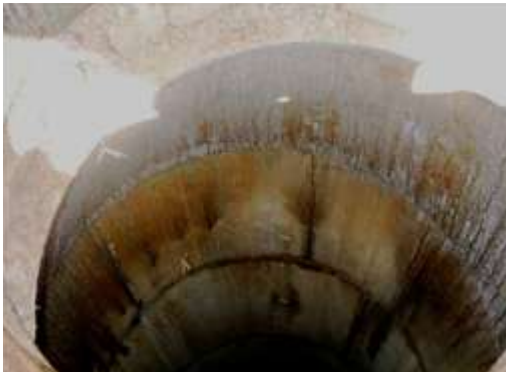
Defect

Frame leaks. Frame offset. Adjustment deterioration and infiltration.

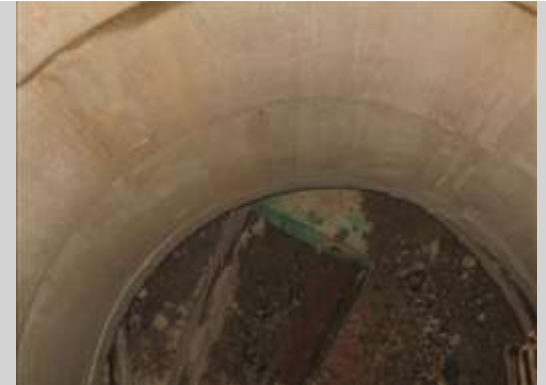
18 in. Circular Gravity Sewer Pipe Out @ 12 O'Clock

Rod and Bar (Angled)

Infiltration: **Evidence**

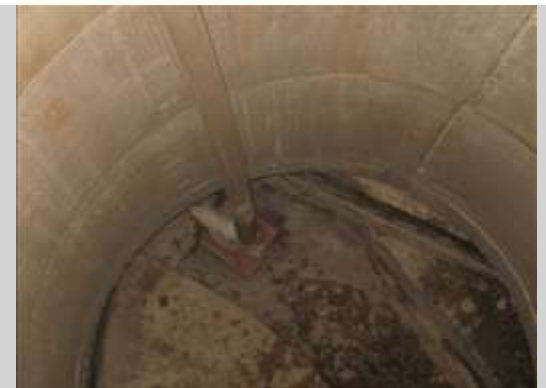
Pipe In @ 6 O'Clock

Capped.

Connects To: **Stub connection / abandoned**
